Residential Engineering Services, P. A.

The purpose of this letter is to address five structural items noted on the home inspection report prepared by ERI Inspection Services (dated 3/6/09) for the property you are purchasing at #293 Pinewood Circle in Fleetwood, North Carolina. A field inspector from our company visited the property on March 19th to visually inspect, measure, and photograph the areas of concern.

Field Sketch

293 PINWOOD CIRCLE
 FLEETWOOD, NC

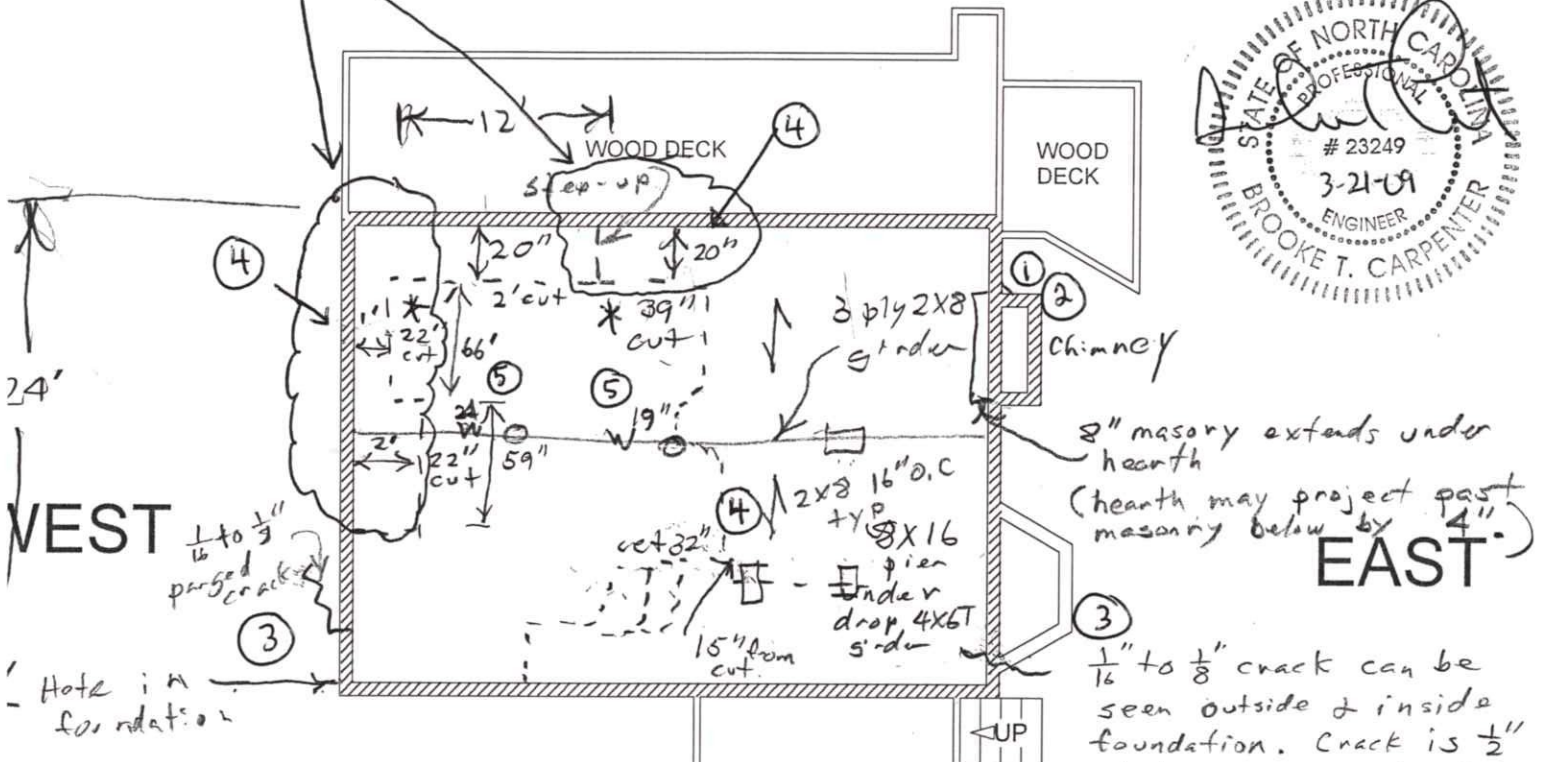
Circled areas require repair w/ soil cuts by foundation

All 3 members of 2x8 girder do not load of 4 1/2" steel columns. 2 piers were removed from these joints due to over dig. center

1/16" to 1/8" crack can be seen outside & inside foundation. Crack is 1/2" at top where mortar fell out of head joint. See photo.

The cracks in the southwest corner are of little concern and may be cosmetically repaired as desired. The cracks in the southeast corner of the home are of greater concern. I recommend excavating this area down to the footing to visually check that the footing has not been cracked. If so, the footing should be reinforced with a set of helical piers installed by a reputable foundation repair company or repaired by removing and replacing the cracked footing (ensuring that the new footing is properly tied into the old footing with drilled and epoxied rebar – 2 ea. #4 bars x 12" (half in/half out)). Regardless of the footing condition, the masonry blocks that are cracked should be removed and rebuilt. Masonry block of the same dimension filled with concrete is recommended.

I recommend excavating and pouring two new 24"x24"x8" concrete footings directly below the joints in the 3-ply 2x8 girder. A U-shaped steel saddle should

be added around the joints for stability (Simpson LCC4.5-4 or equivalent). The steel columns should then be relocated to support the joints and bear on the new concrete footings.

relocate columns under girder joints w/ new 24" x 24" x 8" concrete footings
