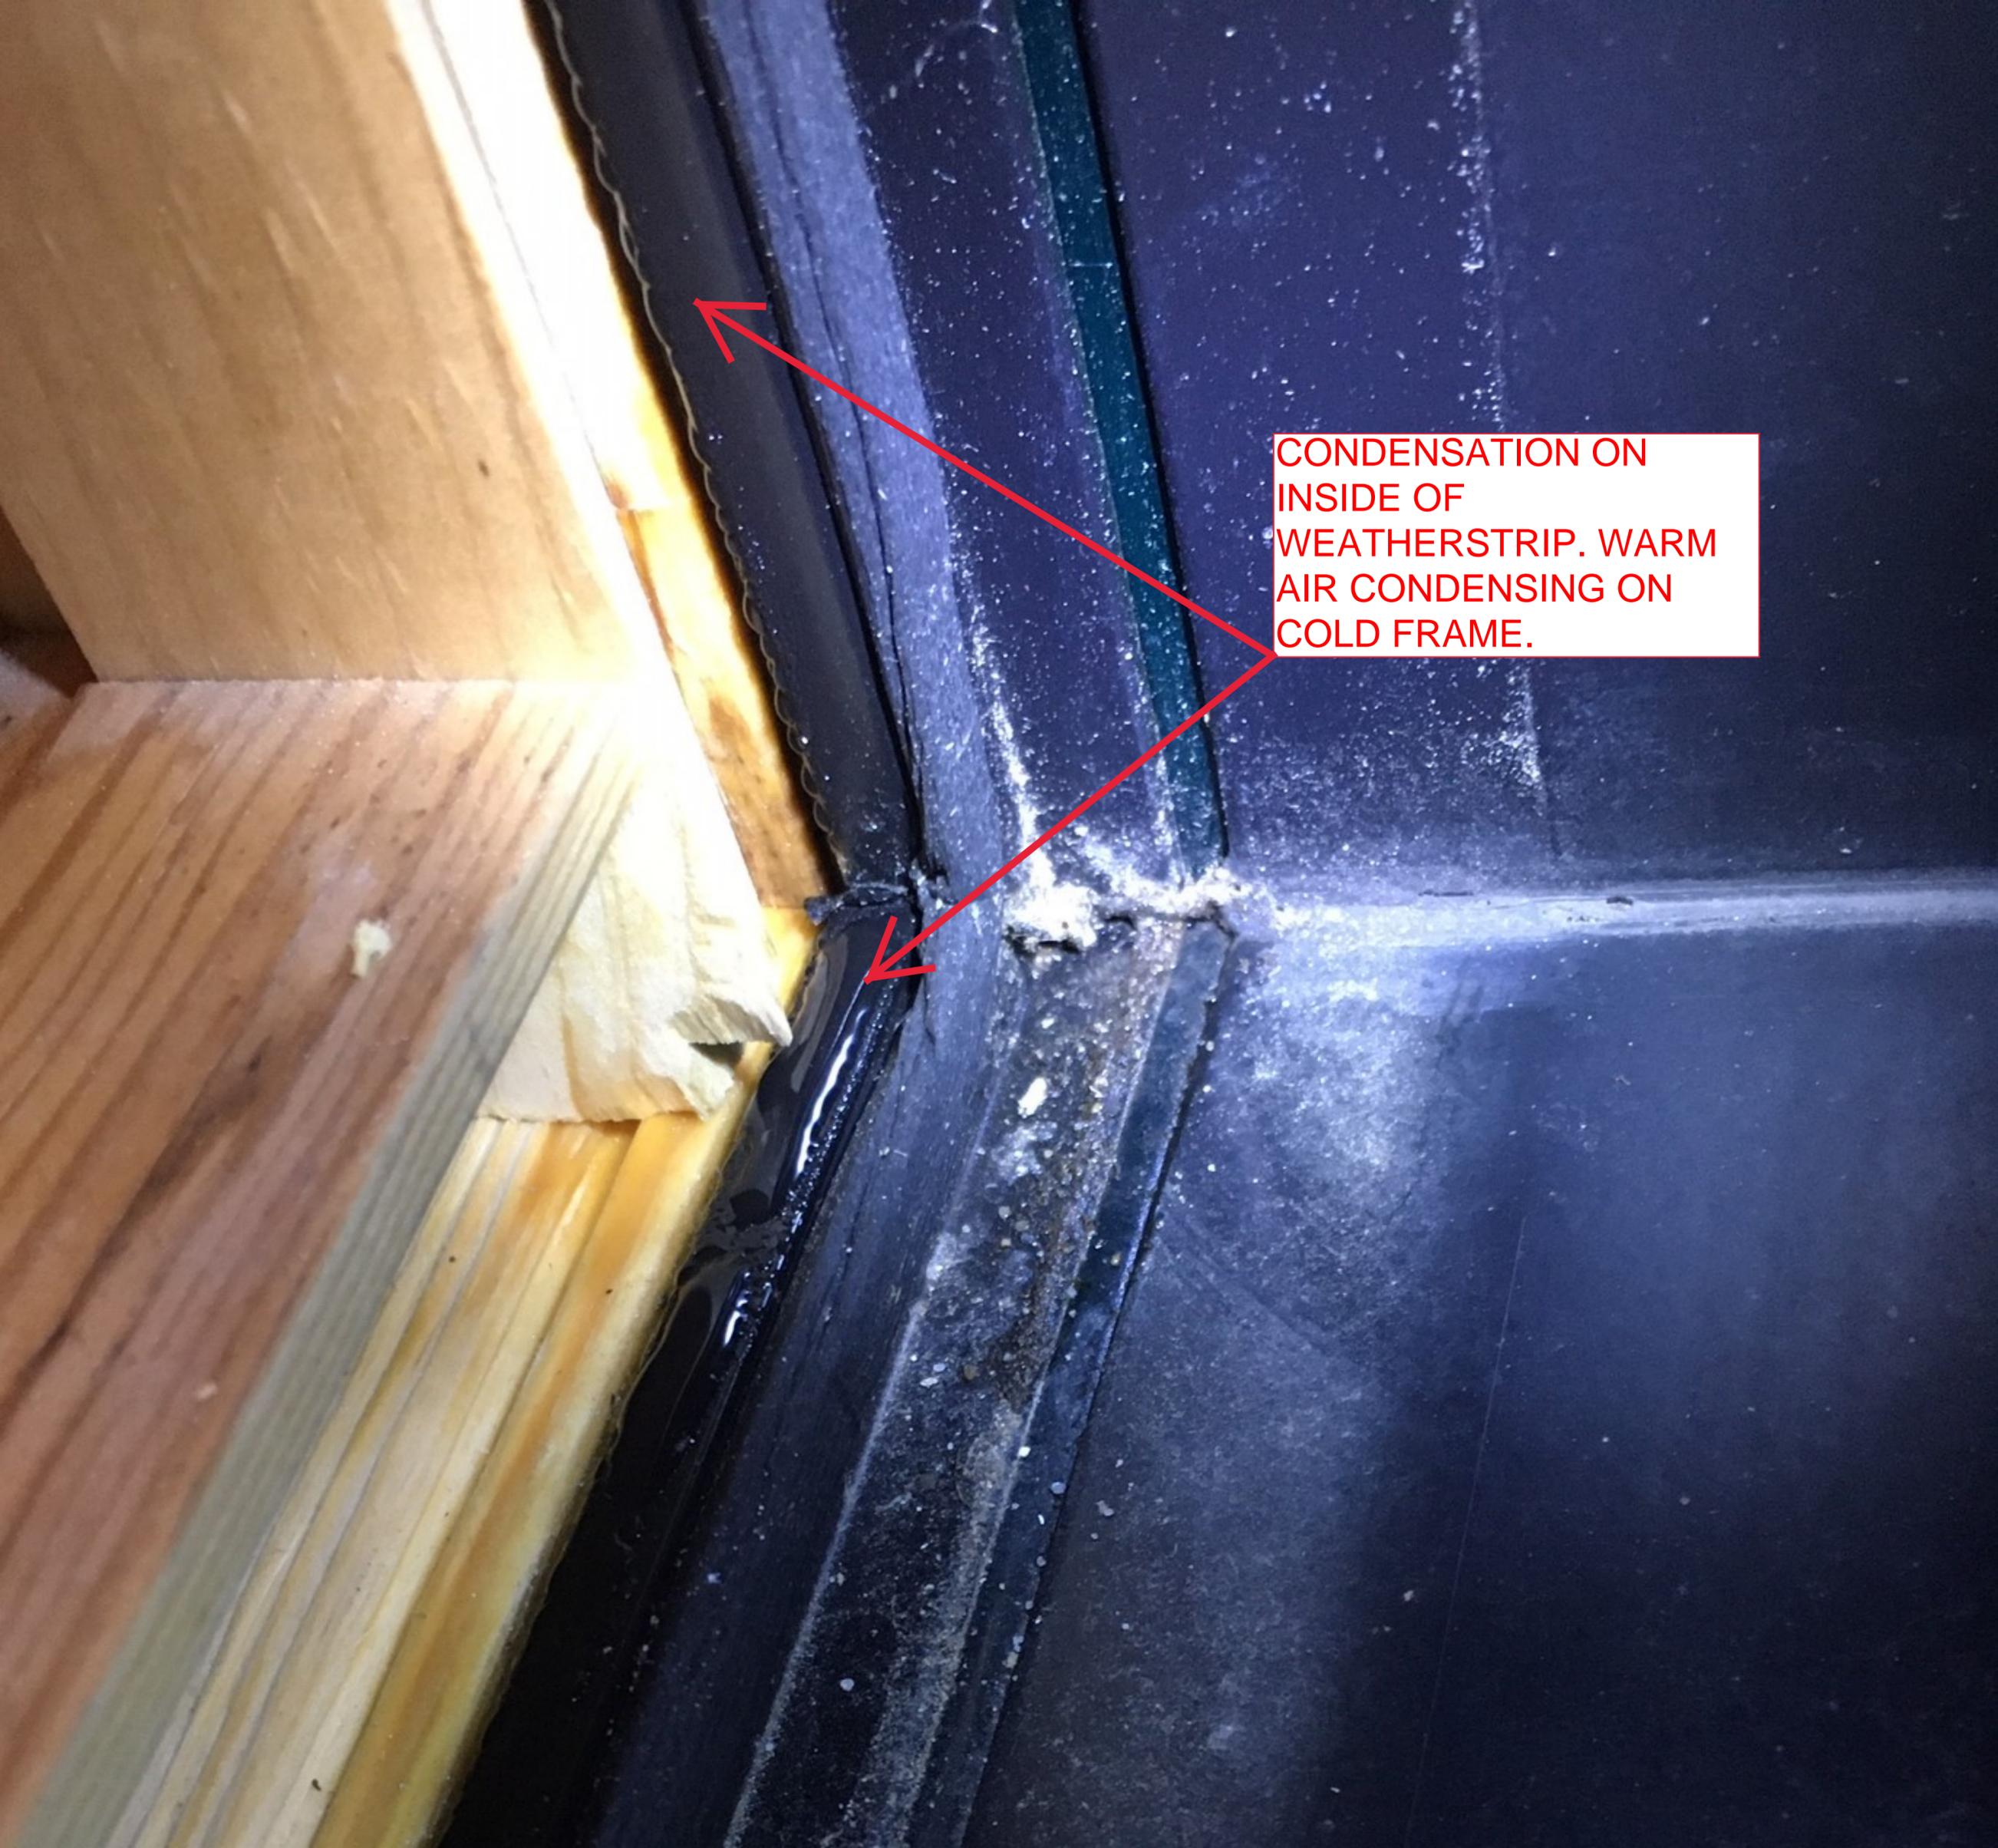
CONDENSATION ON
INSIDE OF
WEATHERSTRIP. WARM
AIR CONDENSING ON
COLD FRAME.

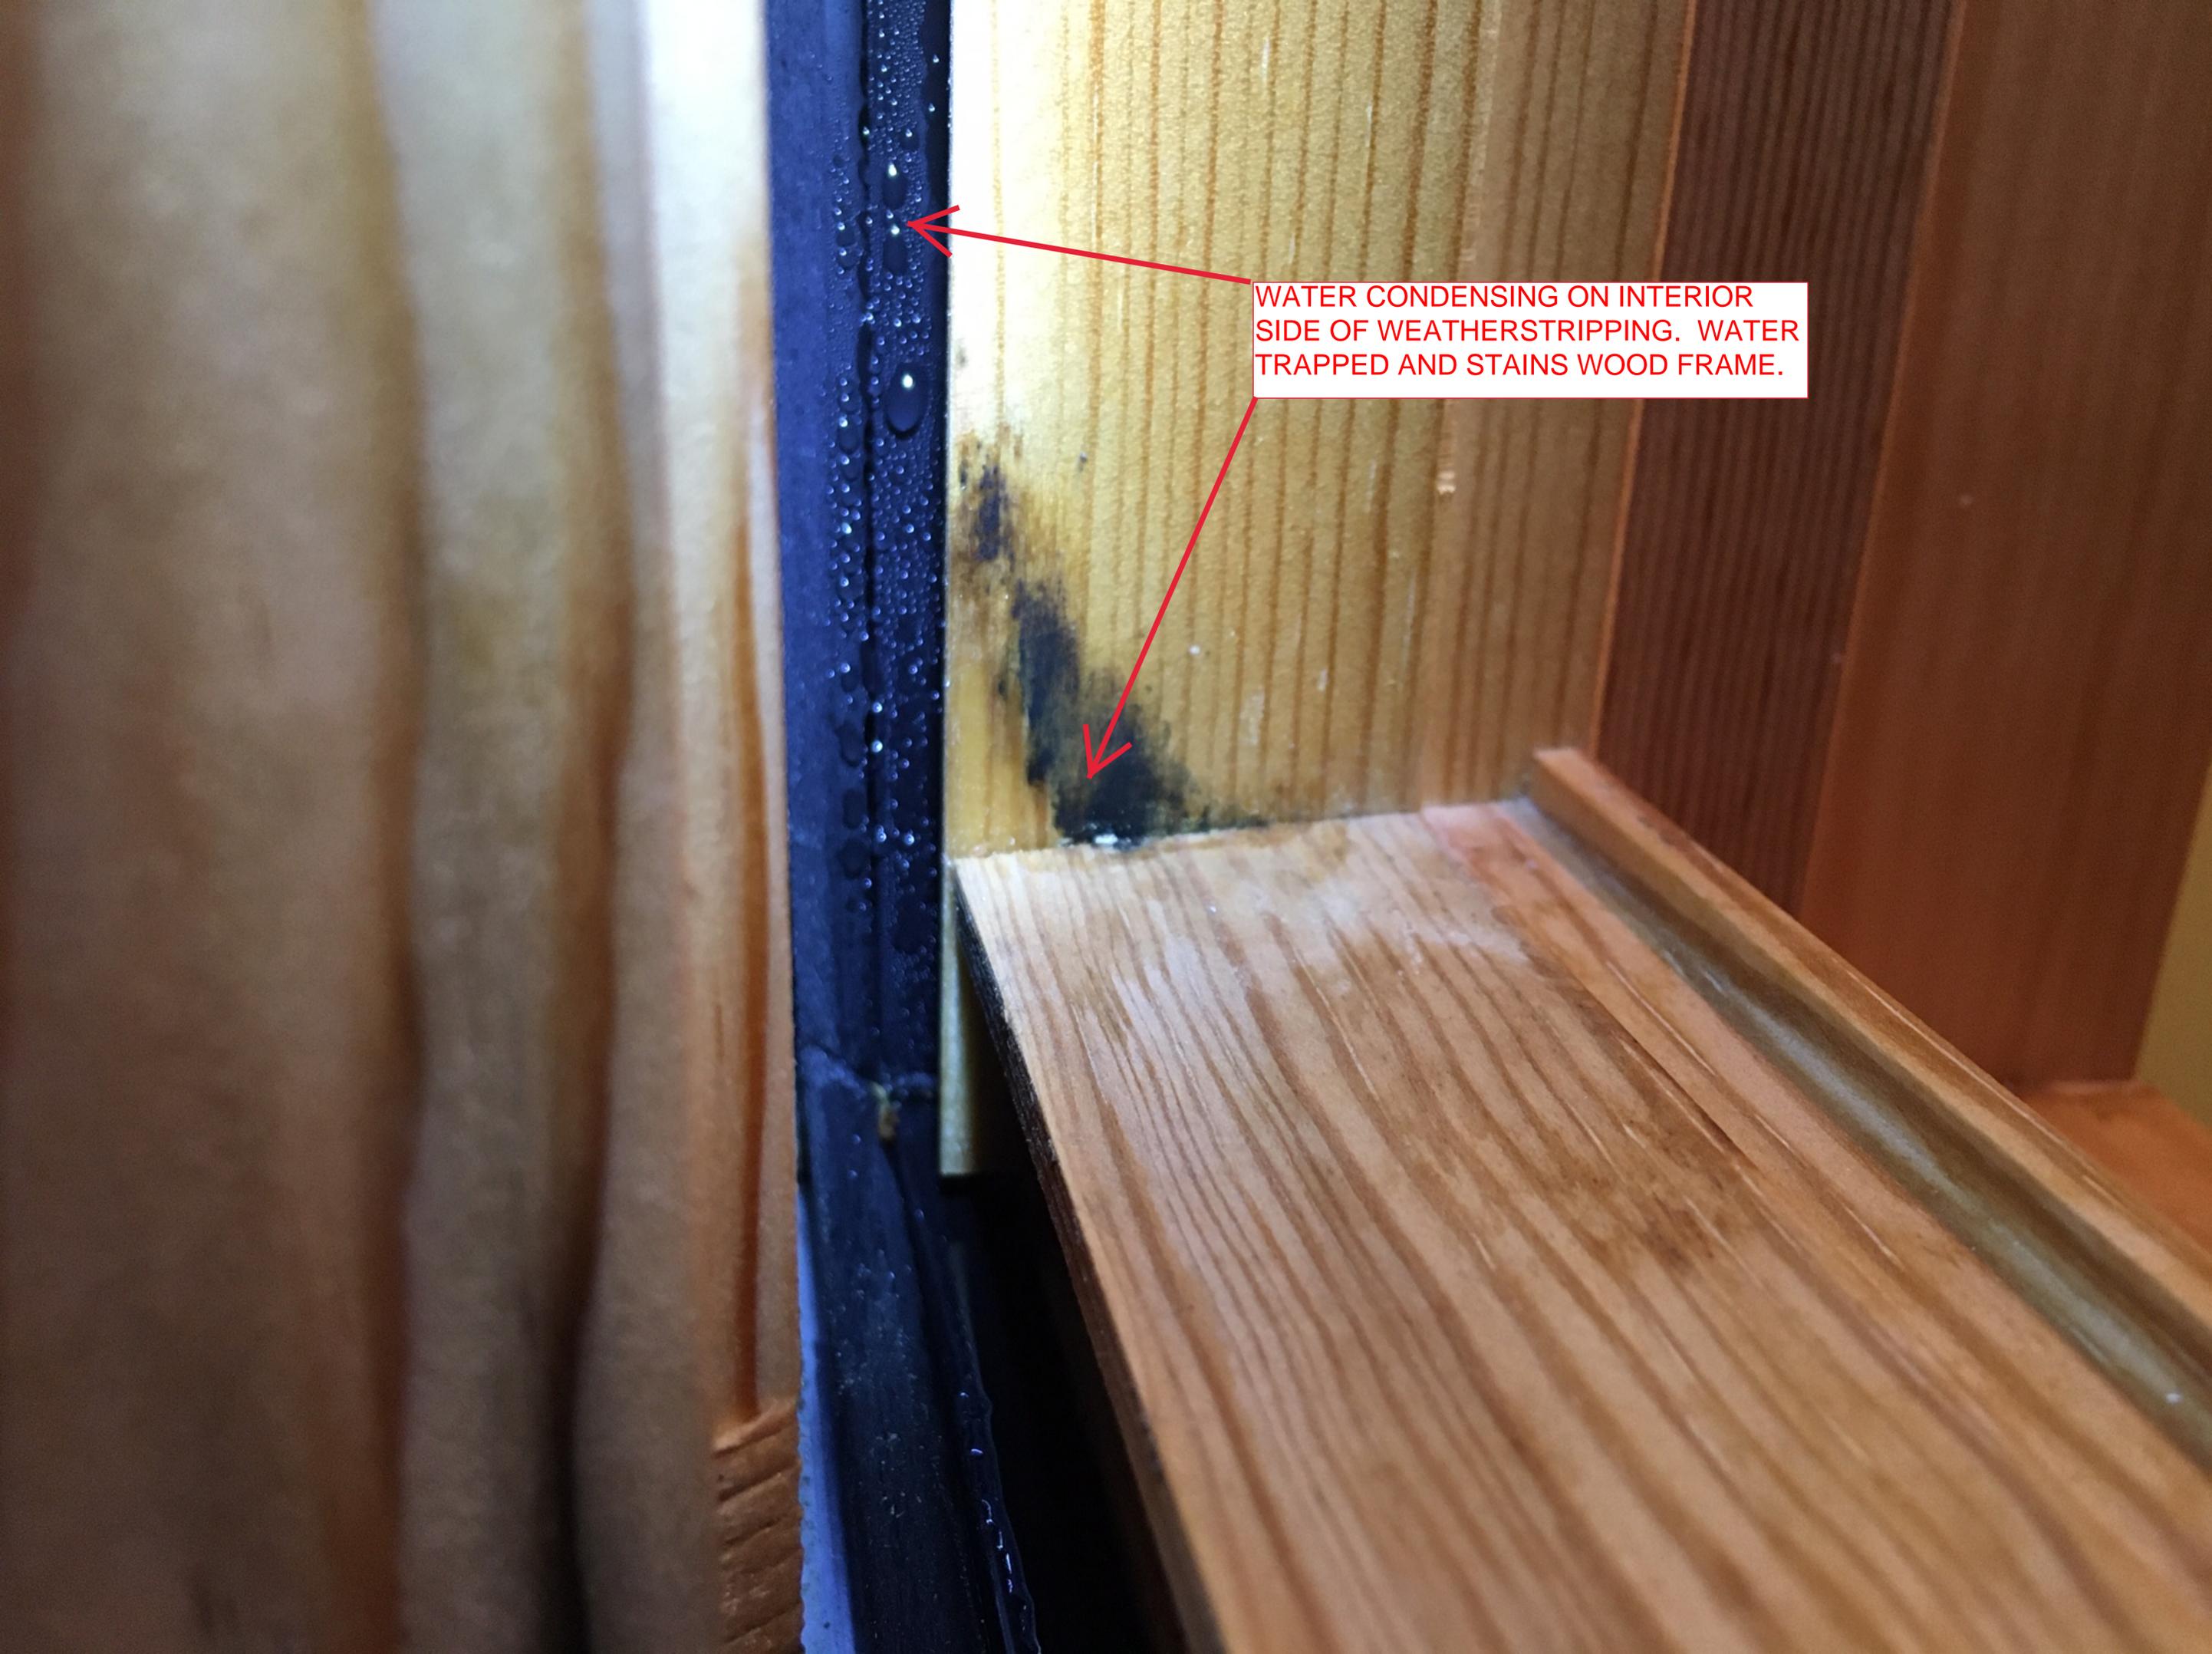
WATER CONDENSING ON INTERIOR
SIDE OF WEATHERSTRIPPING. WATER
TRAPPED AND STAINS WOOD FRAME.

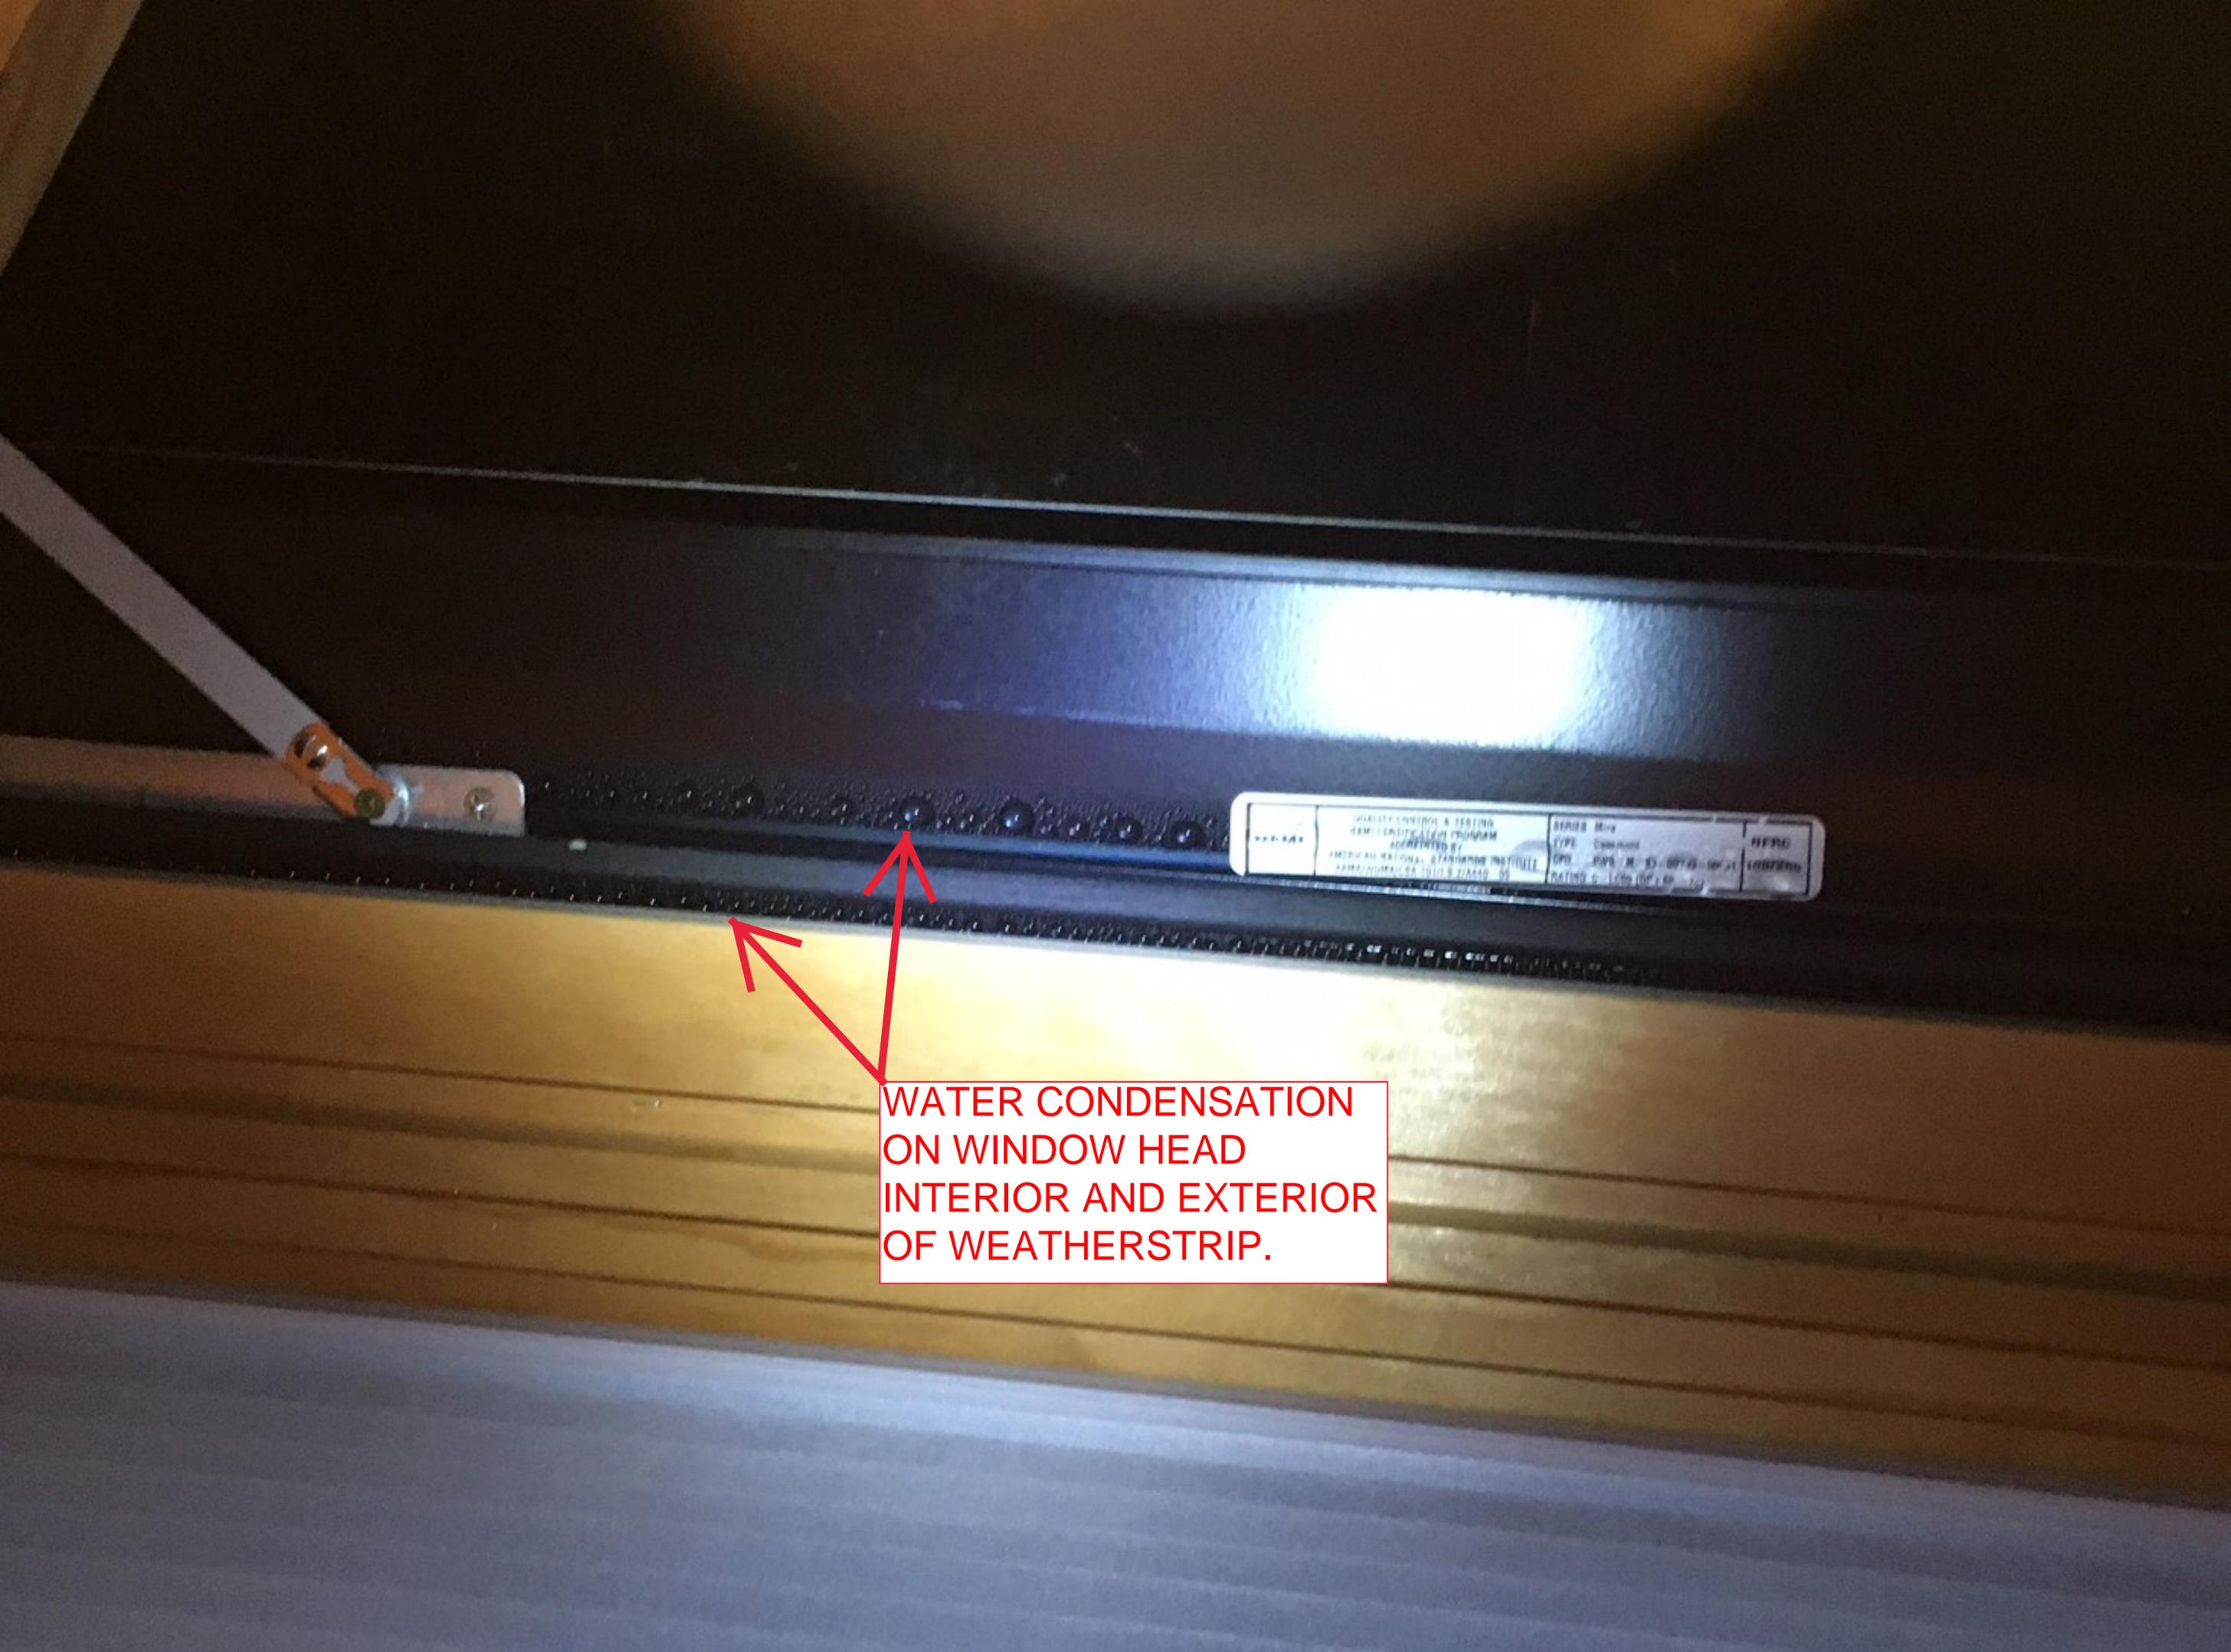
WATER CONDENSATION
ON WINDOW HEAD
INTERIOR AND EXTERIOR
OF WEATHERSTRIP.

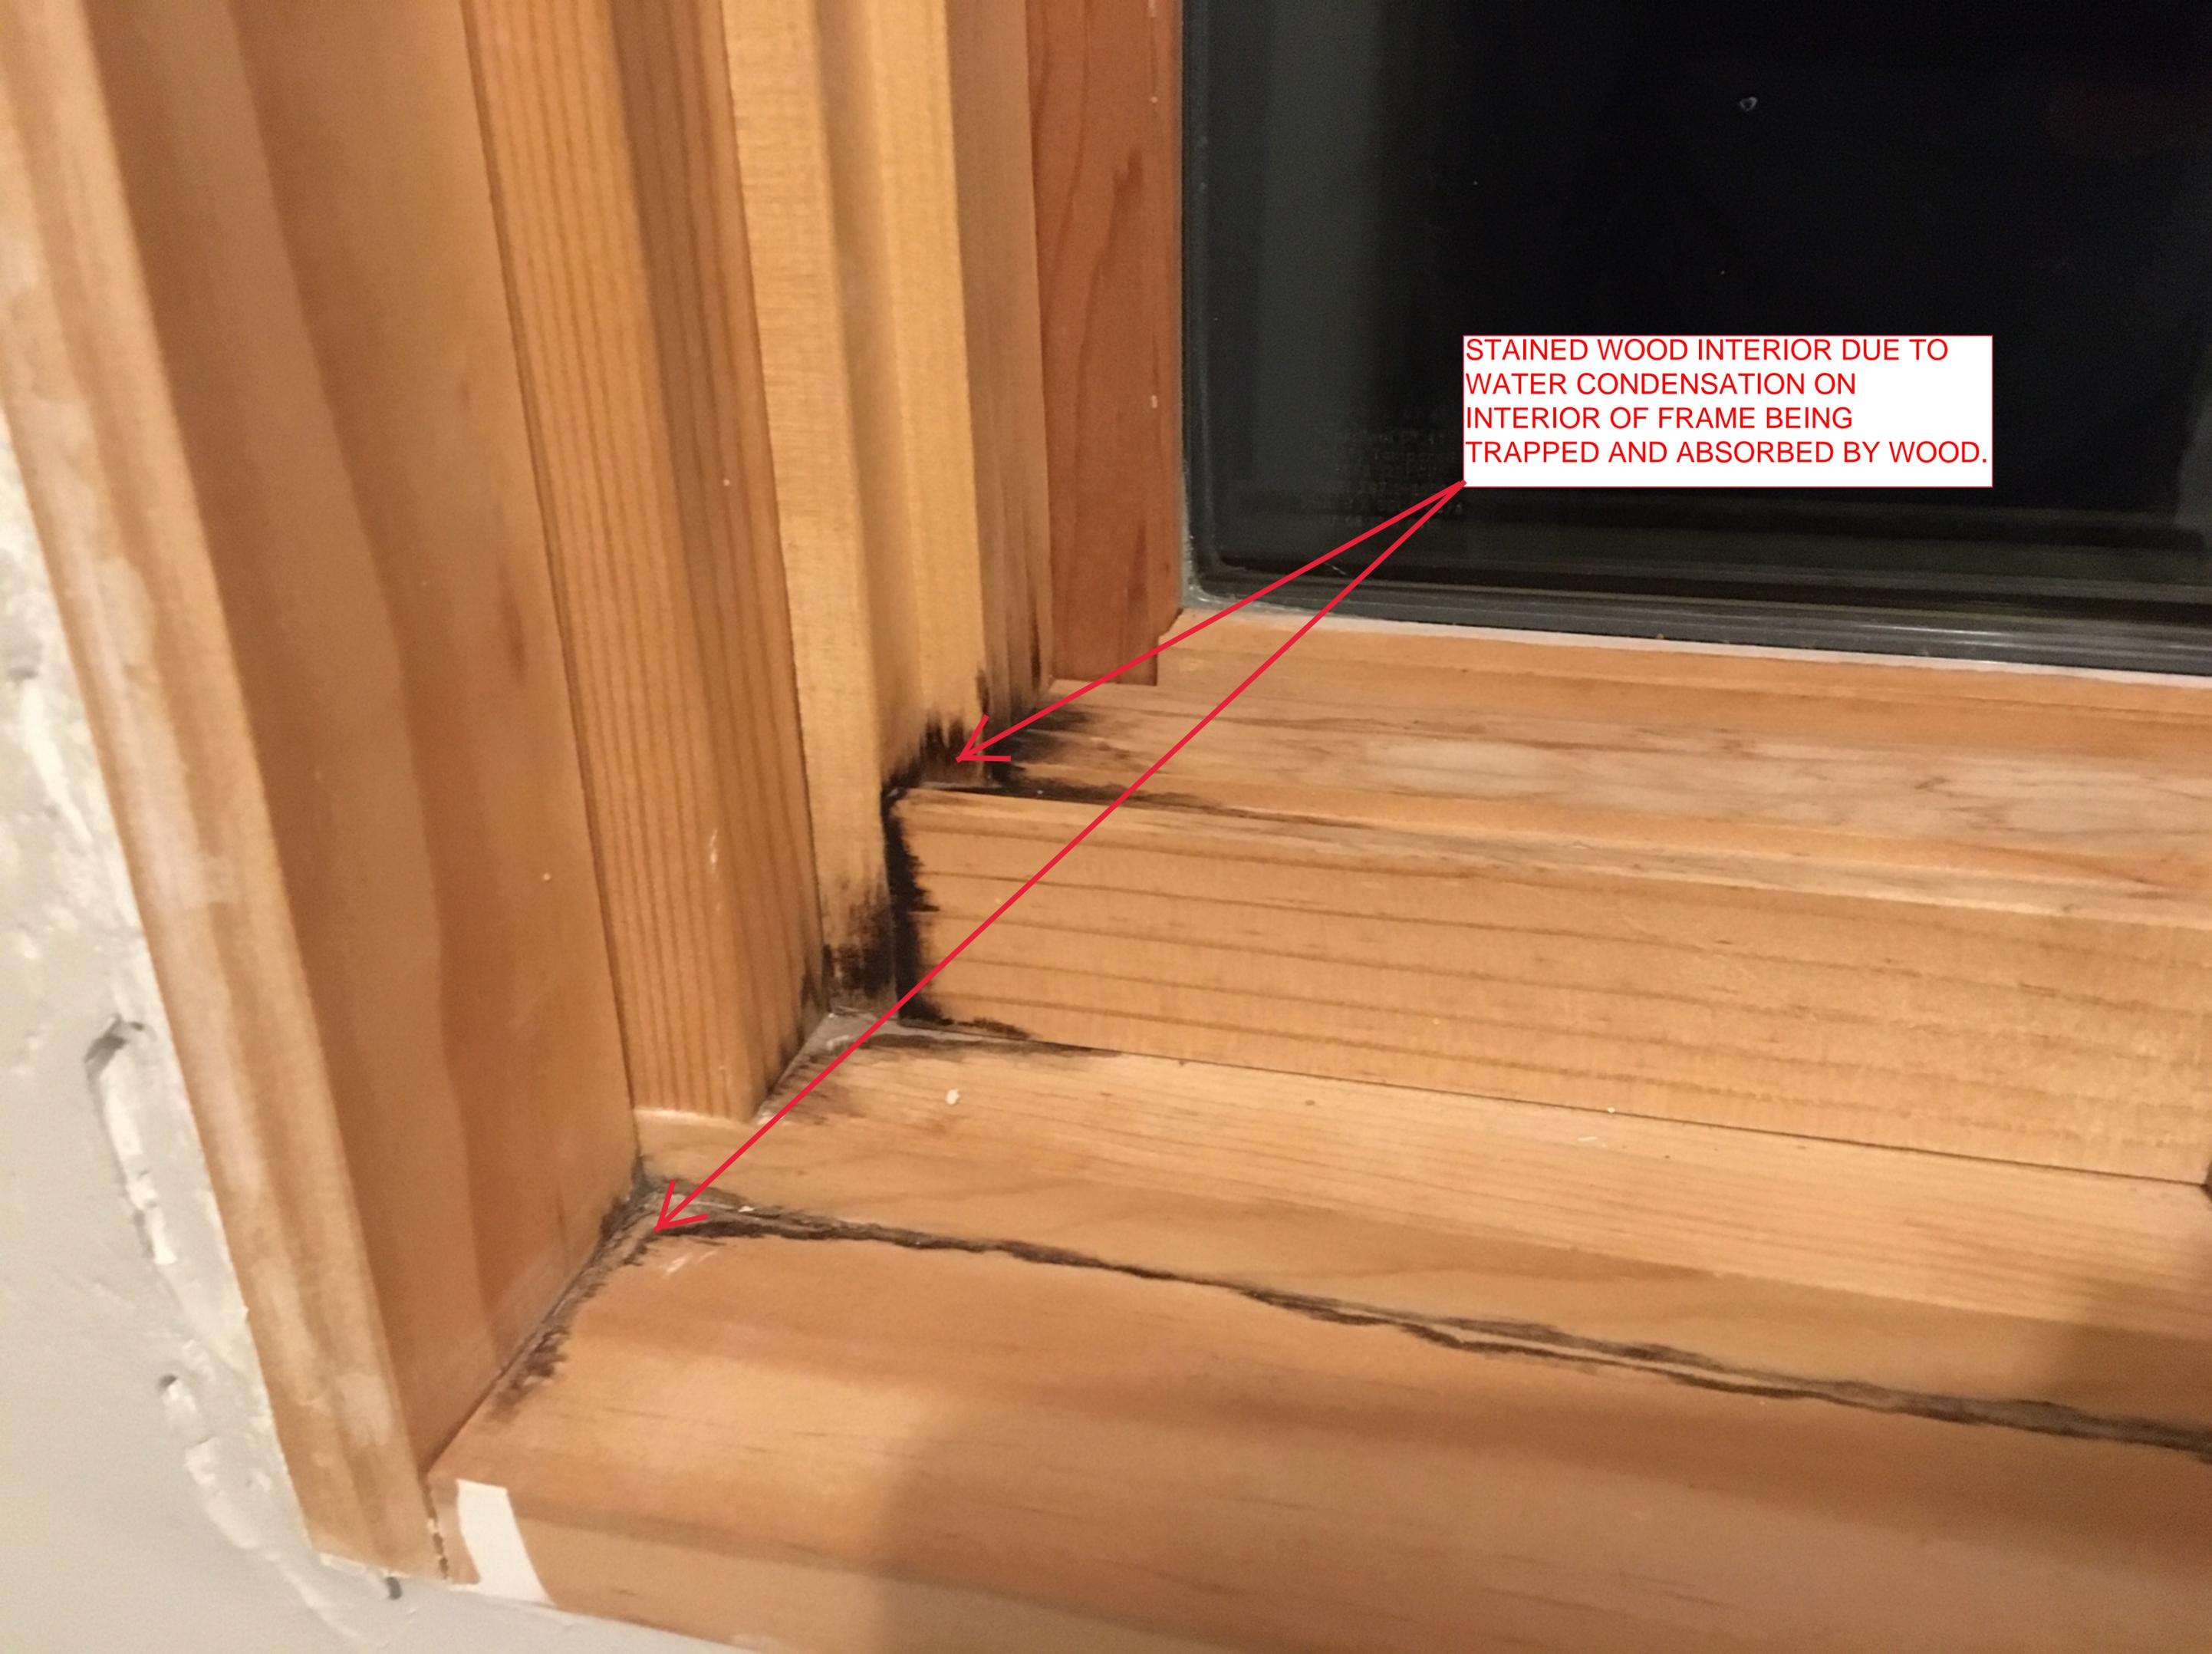
STAINED WOOD INTERIOR DUE TO
WATER CONDENSATION ON
INTERIOR OF FRAME BEING
TRAPPED AND ABSORBED BY WOOD.
