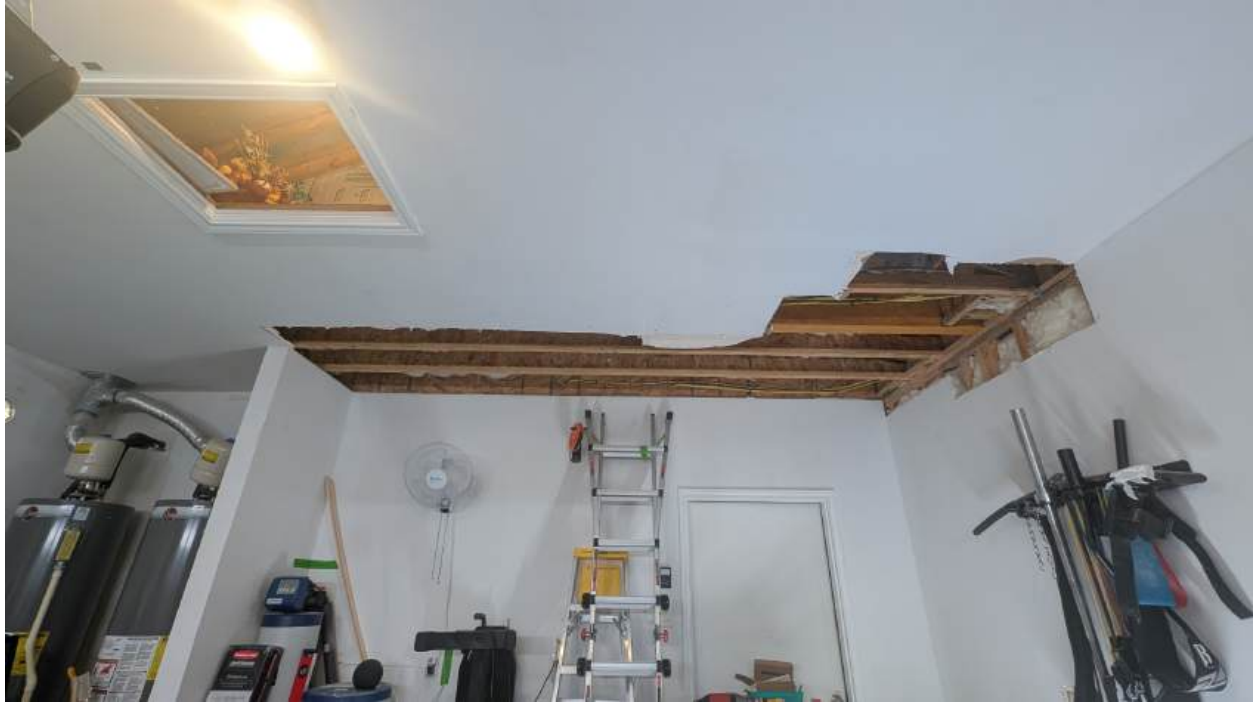
-Whole garage rear

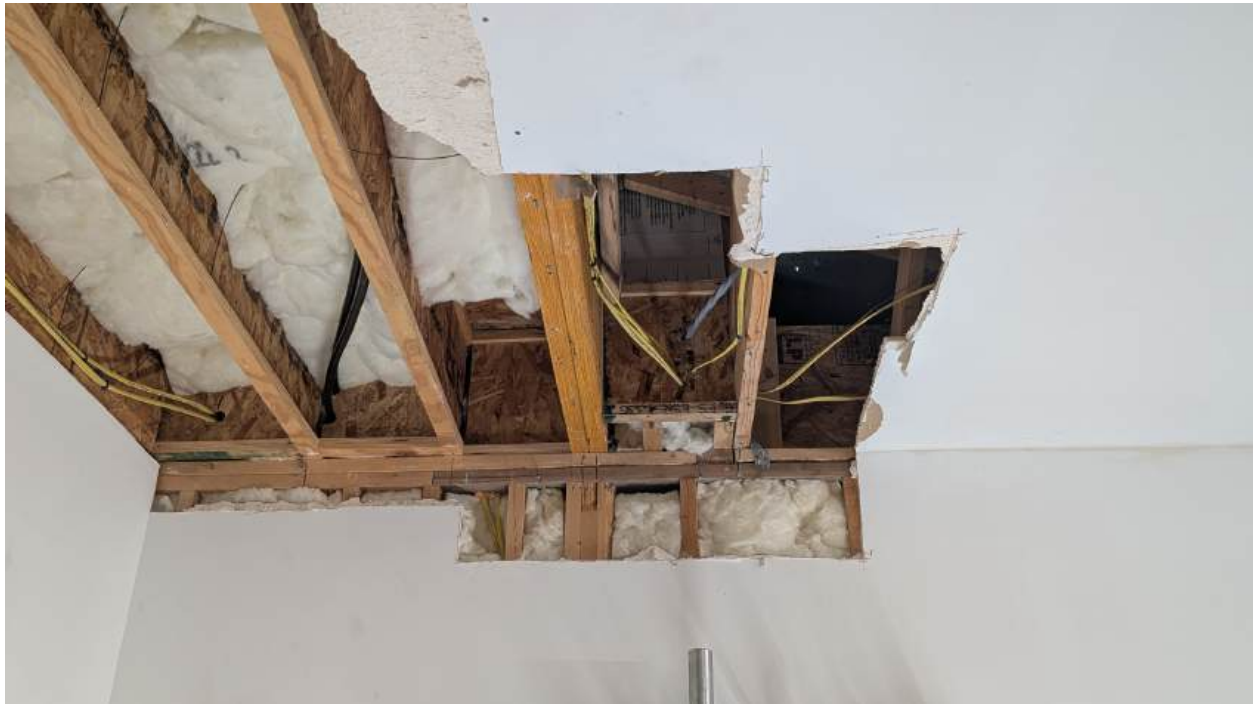
-Living space common walls, living space above. Open space to front porch awning connected to garage attic on the right.

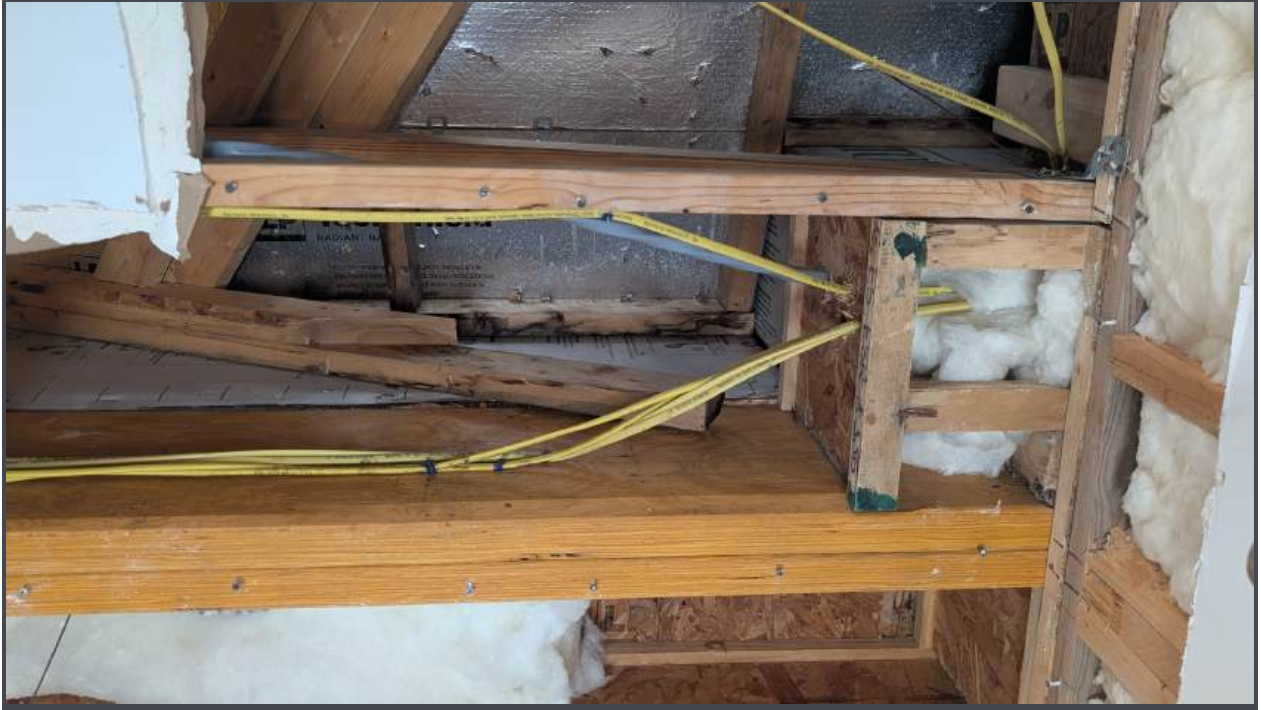
Garage attic radiant barrier. Horizontal beam at joint is point of water intrusion.

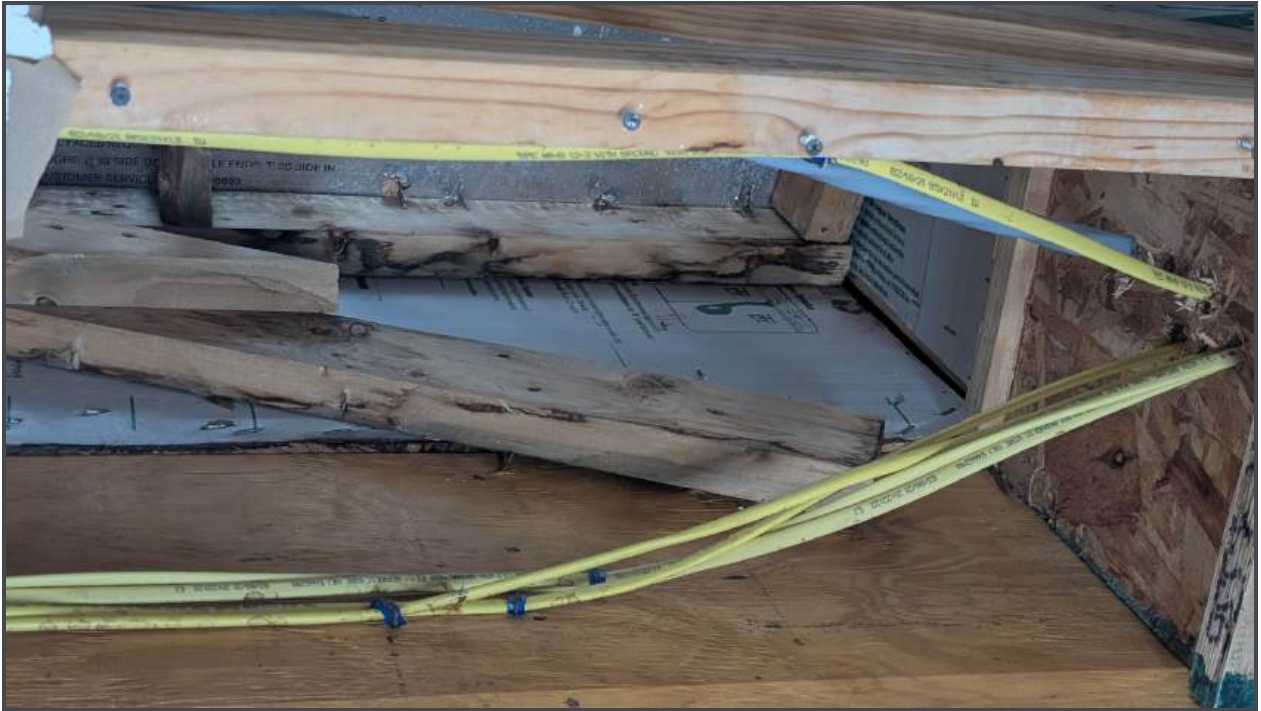
Horizontal beam at top of thermoply - point of water.

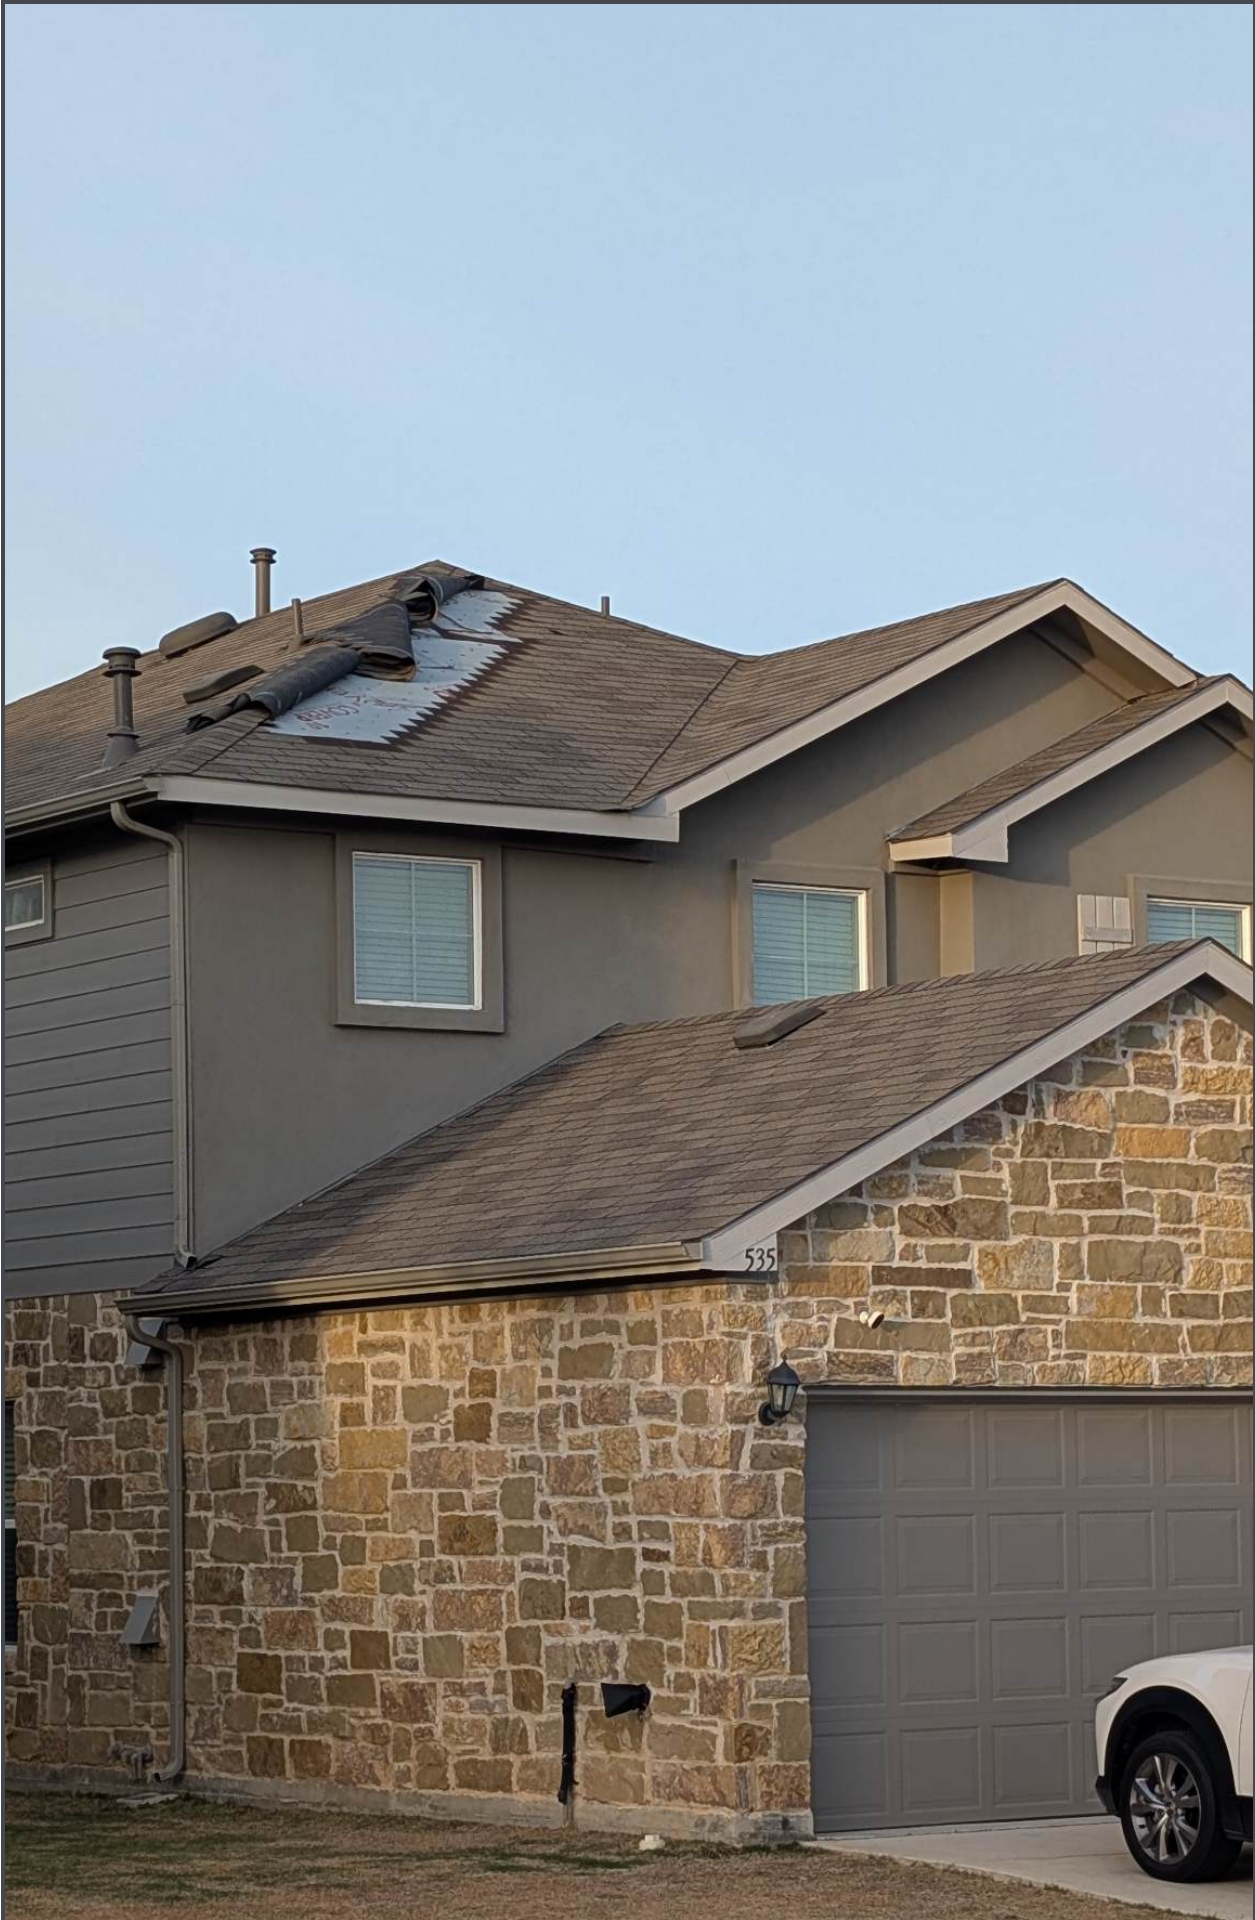
Garage extends 3-4 feet under 2nd story(fresh air for water heaters in garage by gutter, water heater vent at roof). Middle window is the problem.
