Use of Dissimilar Metals in Building Façades

Testing the common knowledge

by Jeffrey J. Ceruti, PE
Photo ©BigStockPhoto.com

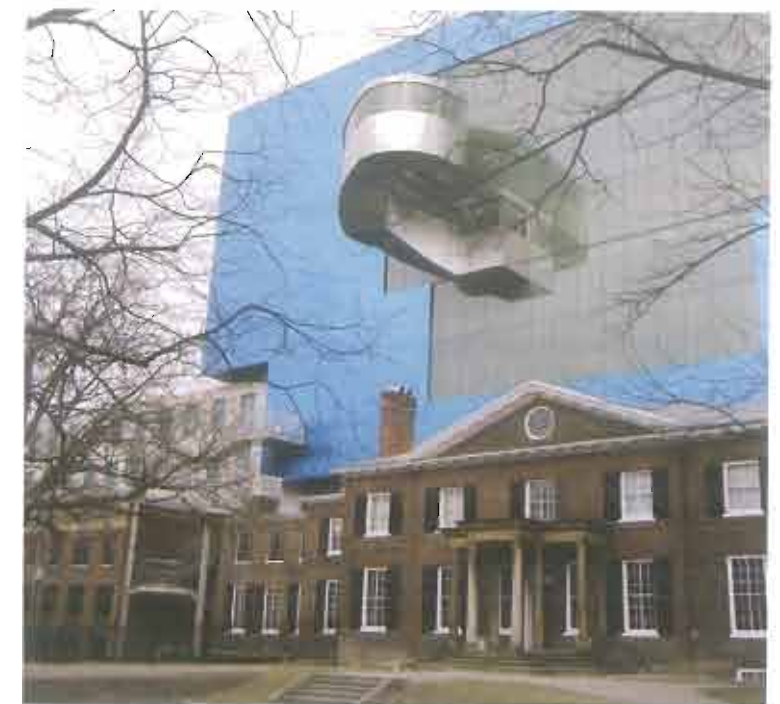
Toronto's Art Gallery of Ontario (AGO) marks the first Canadian building by native son, Frank Gehry. Among its many design features is the striking use of blue titanium and other metals. Use of dissimilar materials can have an impact if corrosion is not taken under consideration.

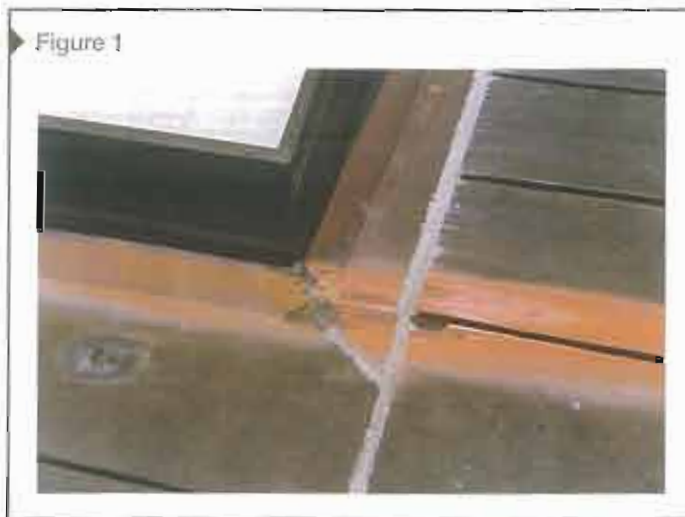
Figure 1
Corrosion occurred on this copper roof where condensation dripped from an aluminum skylight, while the remainder of the roof turned dark brown due to the influence of normal weathering. Images courtesy Simpson, Gumpertz, and Heger

Condensation collected in the skylight gutter system and drained onto the copper roof, as designed. However, these portions remained a bright red while the rest turned dark brown.

The lack of appropriate industry references first came to this author's attention in the early 1990s, after observing a copper roof suffering from corrosion beneath an aluminum skylight. Condensation collected in the skylight gutter system and drained onto the copper roof, as designed. However, the copper in these locations remained a bright red color while the remainder of the roof had begun its normal oxidation process, turning dark brown after a few months of exposure (Figure 1). In reviewing various galvanic series charts, the consensus was copper would not corrode preferentially to aluminum, because aluminum was far more 'active' than copper. The standard charts did not predict the corrosion pattern.

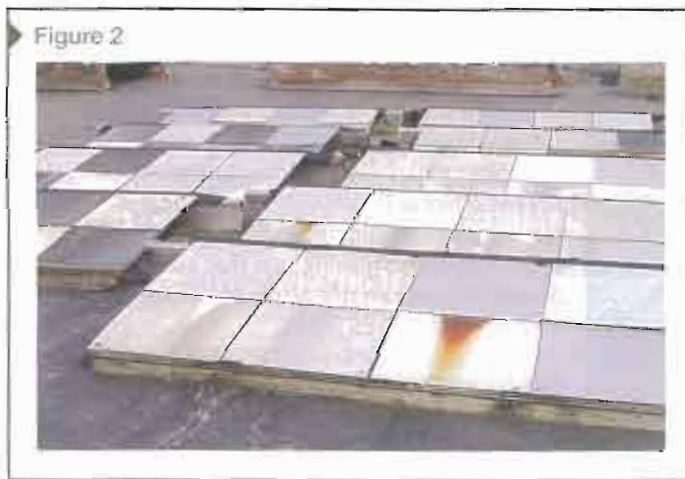
Figure 2
For the test assemblies in suburban Massachusetts, different pieces of metal are loose-locked together and mounted on wood frames set at a 10-degree slope, with the lock 'shingled' to shed water.

The test assemblies comprise 305 x 305-mm (12 x 12-in.) pieces of each type of sheet metal, formed with a 12.7-mm (0.5-in.) hem on one side of every piece. Different pieces of metal are loose-locked together and mounted on wood frames set at an approximately 10-degree slope, with the lock 'shingled' to shed water (Figure 2). Two samples were made for every combination of the different metals tested, alternating the 'upper' and 'lower' sheet orientation. Before installation, each specimen was measured, weighed, and identified.

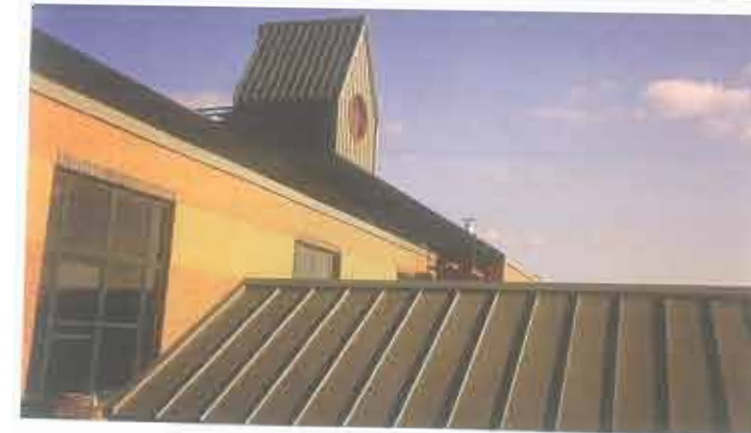
Architectural façades have become more complex. Buildings now commonly include multiple materials that may be incompatible over the long term. With current data lacking, further research is needed.

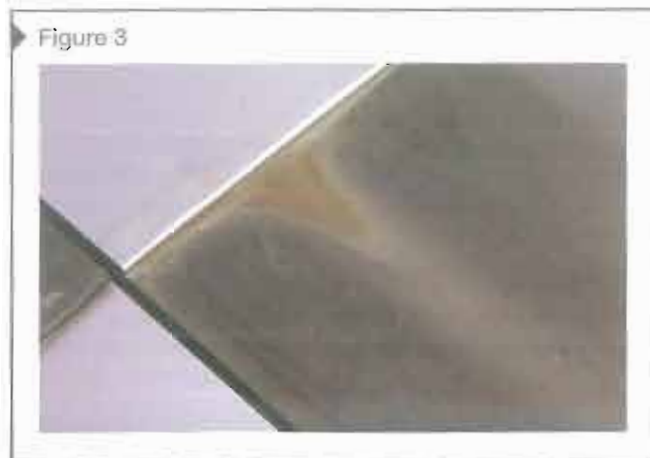
Figure 3
Runoff from stainless steel caused a portion of the copper panel to remain bright and shiny, indicating corrosion.

Type 304 stainless steel, when in its naturally passivated state, is clearly the most noble of the metals tested and has caused staining and corrosion on all samples, except those with aluminum surfacing. Stainless steel draining over copper caused a portion of the copper

to remain bright and shiny, indicating corrosion (Figure 3). Stainless steel over lead-coated copper corroded portions of the lead (Figure 4).

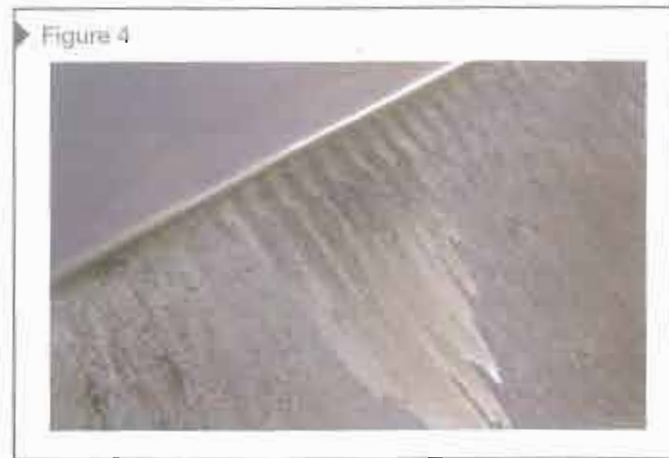
Figure 4
Stainless steel over lead-coated copper corroded portions of the lead. It caused staining and corrosion on most samples.

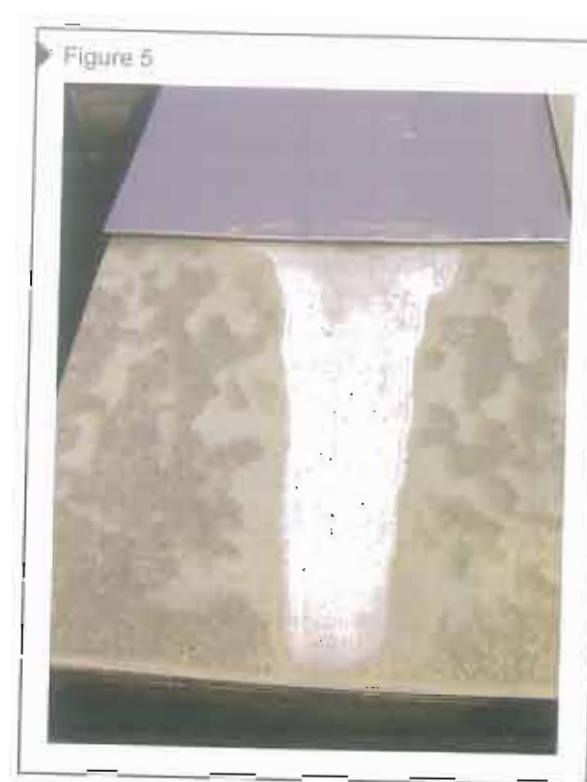
Figure 5
Stainless steel draining over tin/zinc-coated steel and copper caused white/gray staining on both pieces, indicating initial corrosion of the protective coating.

Having stainless steel draining over tin/zinc-coated steel and copper caused significant white/gray staining on both pieces. This indicates the initial corrosion of the protective coating.

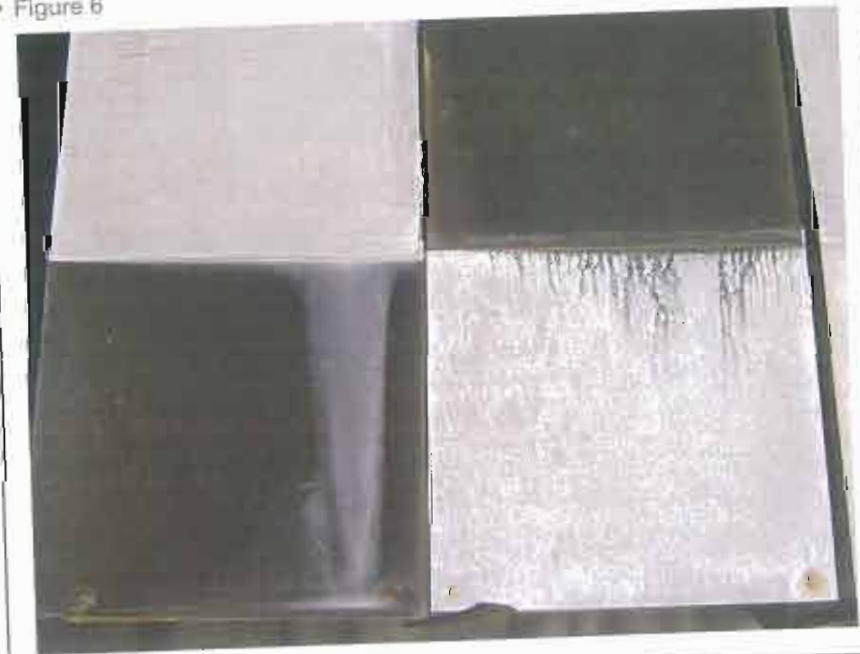
Figure 6

Heavy black streaking occurred on the lead-coated copper sheet below the copper.

Heavy black streaking occurred on the lead-coated copper sheet below copper (Figure 6), and copper also caused staining on the tin/zinc-coated metals and some green staining on the aluminum piece. Copper over the Al/Zn-coated steel resulted in severe coating loss and rusting of the steel base (Figure 7).

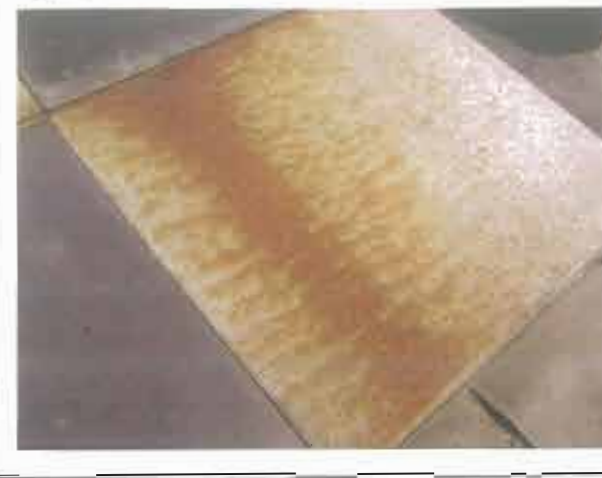
Figure 7

Copper over the aluminum/zinc-coated steel resulted in severe coating loss and rusting of the steel base.

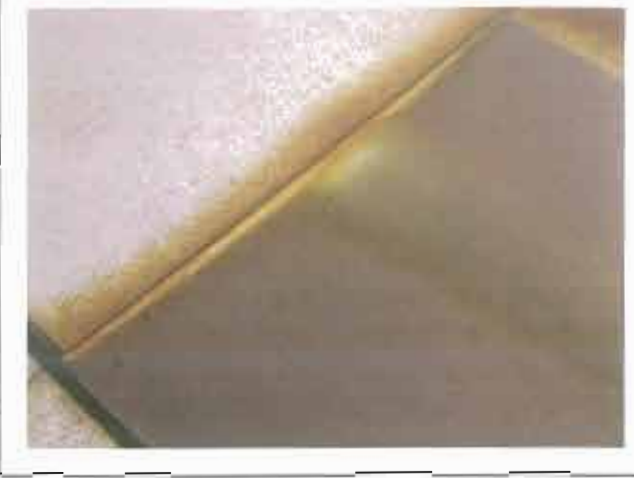
Figure 8

Corrosion product occurs within the lock between aluminum/zinc-coated steel and the copper.

Unlike stainless steel, however, all the other metals cause at least some minor gray staining on the lower copper sheet. This may be from deposits of the upper metal onto the copper below or, in the case of galvanized steel and Al/Zn-coated steel (Figure 8), due to corrosion product within the lock that flows onto the copper.

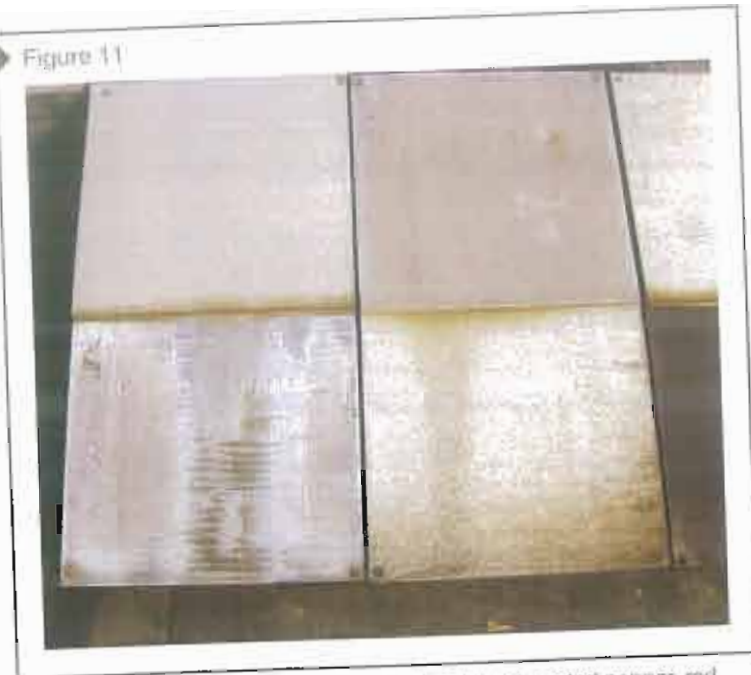
Figure 11
When pairing aluminum/zinc-coated steel with lead-coated copper, red rust occurred at the lock of both sample orientations, indicating failure of the aluminum/zinc coating and corrosion of the base steel within the lock.

The reaction between lead-coated copper and Al/Zn-coated steel is severe—red rust has occurred at the lock of both sample orientations, indicating failure of the Al/Zn coating and corrosion of the base steel within the lock (Figure 11, page 104). When oriented on the lower sheet, the lead coating

is affected by the Al/Zn coating and has a shiny gray streak with black staining. Lead-coated copper has caused corrosion of the galvanized steel, resulting in red rust at the lock area. A faint white stain occurred on the tin/zinc-coated metal below lead-coated copper.
