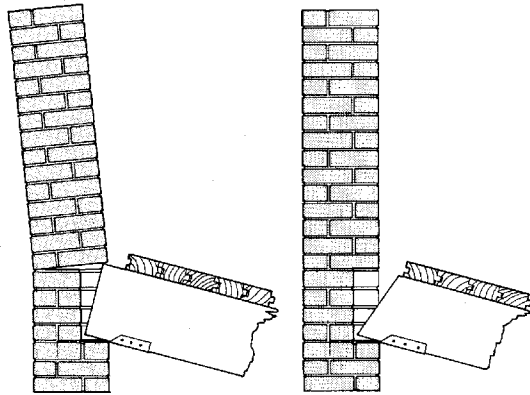
FIGURE 4.10
A timber beam that burns through in a prolonged fire is likely to topple its supporting masonry wall (left) unless its end is firecut (right). The beam is anchored to the wall in each case by a steel strap anchor of the type shown in Figure 4.13
